Under Arctic conditions in Europe: Norwegicin Orlong

Norway was the first European nation to operate Lockheed Martin P-3 Orions. Marco P J Borst reports on the roles of the Norwegian Orion fleet which is about to be updated in order to retain its anti-submarine warfare capabilities.

AIR International • January 1998

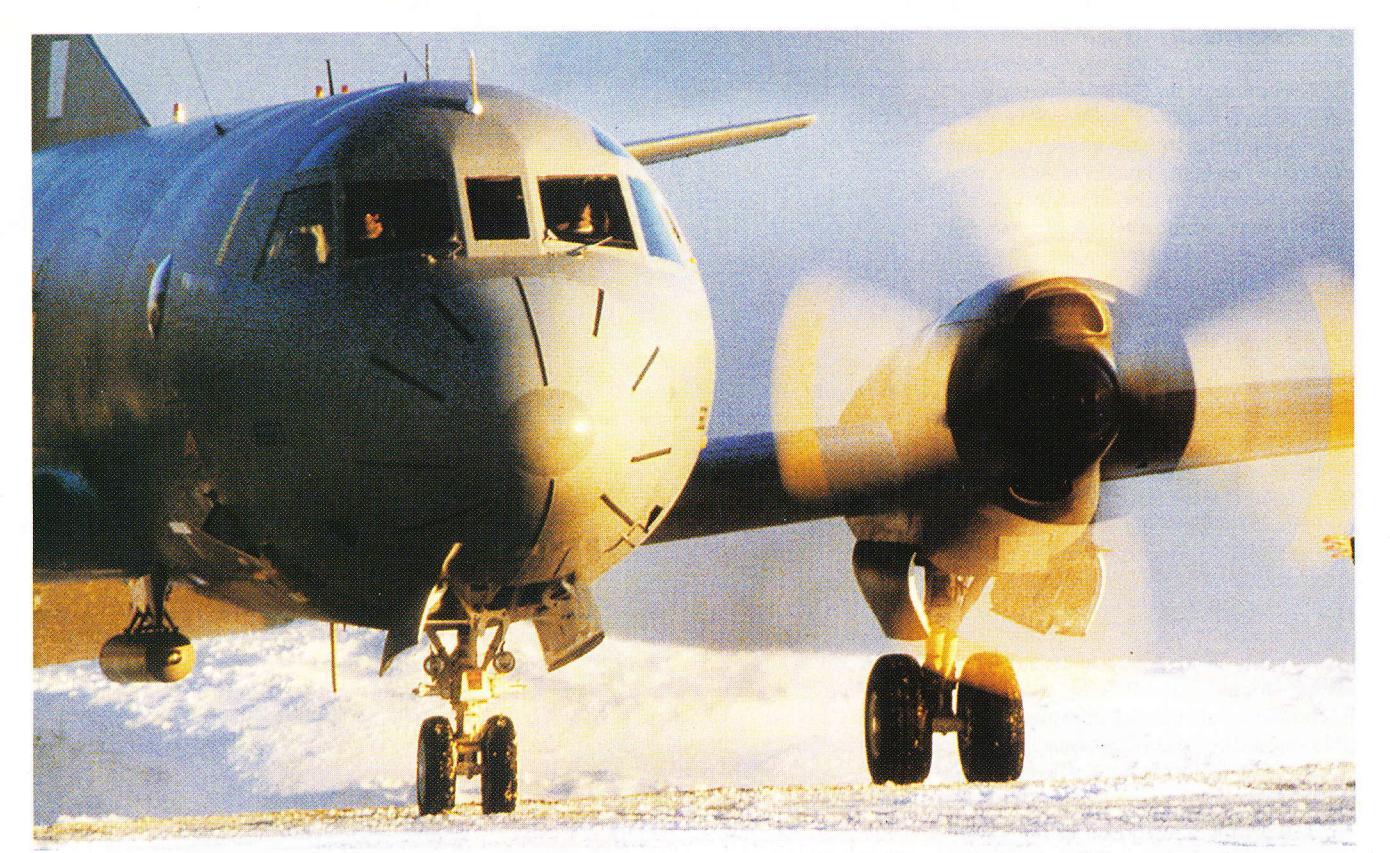
Above: This view of P-3N 6603, taxiing to its parking bay at Andøya, shows the location of its Radiak sampling pod. (All photos via Author)

Until their retirement the P-3N Orions will continue to relieve the P-3C-III fleet by conducting pilot training flights, coastguard missions and flight-testing equipment. As an example of the latter, P-3N 6603 is currently involved in the development of Radiak, a system devised to detect and record radioactive radiation. Radiak consists of an equipment pod, four sensors below the aft fuselage and a separate work station in the rear of the aircraft. Development of Radiak was found necessary after the nuclear disaster in Chernobyl and an accident with a nuclear Russian submarine. Norway is sufficiently close to Russia for its potentially unstable nuclear installations to be of concern.

During a sampling mission the Radiak system's equipment pod, which is carried below the inner side of the starboard wing, collects air samples in a filter — a valve in the pod's nose can be opened via a switch on the radar operator's work station. On completion of the sortie the system is able to print out a map which shows the route flown by the P-3 and is colour coded to show the intensity of the radiation. When Radiak is fully developed, the system will become available in a roll-on/roll-off configuration. All four P-3C-III Orions will eventually be wired for Radiak and the system's heavy sensors will probably be carried in the P-3's weapons bay instead of its present installation below the cabin floor in the aft fuselage.

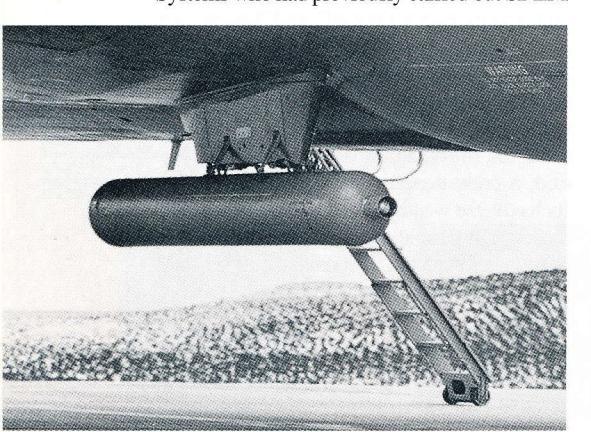
Above: Close-up of the Radiak pod mounted on the inner starboard underwing hardpoint of P-3N 6603. The pod and its associated system was designed and manufactured by 333 Squadron engineering personnel and is currently in the development stage. When fully developed it will be offered on the market to customers such as NATO.
